Site 39 Inland Ranges Habitat Restoration Status Update

October 12, 2016

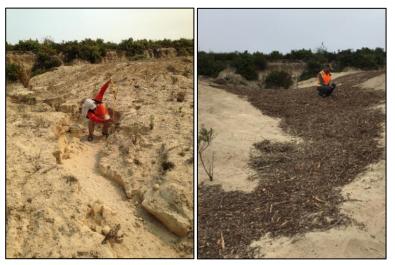
Photos 1 & 2: Before and during erosion control repairs at HA 27A.

• Continuing with "dry season" erosion control repairs HAs 27A, 28, 34 and 37
