Site 39 Inland Ranges Habitat Restoration Status Update

October 22, 2015

Erosion Control Repairs

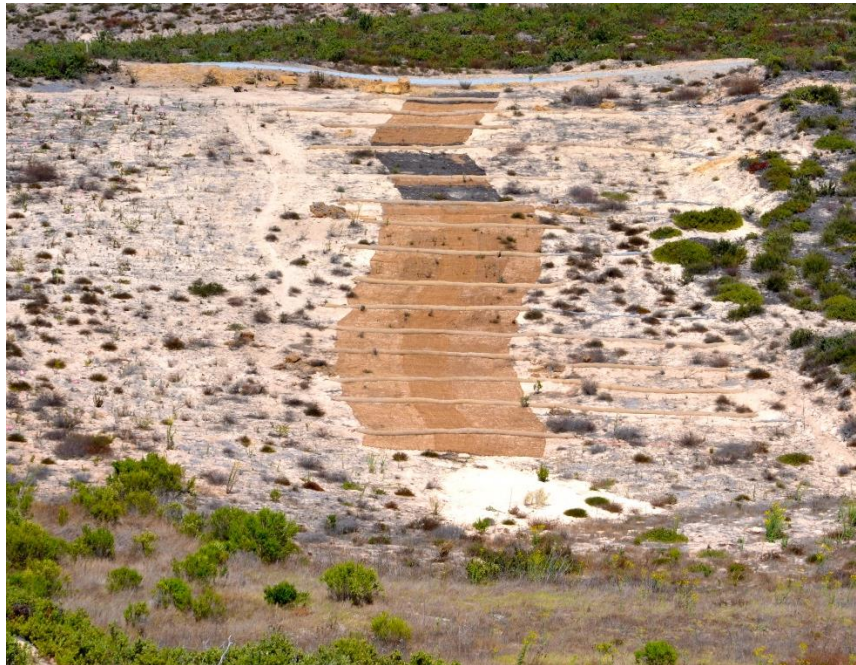
Figure 1 HA 28 post erosion control repairs.

HA 28 Erosion Control Repairs

- Collapsed approximately 200 linear feet of rills
- Installed 550 Linear Feet of straw rolls (stakes still need to be driven to depth)
- Installed 3,350 square feet of coir fabric
- Broadcast erosion control seed mix over ~0.5 acres (11 lbs Elymus and 50 Hordium)
- Broadcast straw mulch and crimped over ~0.5 acres
