Track 1
Plug-In Approval Memorandum
BLM-Headquarters and MRS-35
Former Fort Ord, California

March 24, 2011

United States Department of the Army
Base Realignment and Closure (BRAC)
Former Fort Ord, California

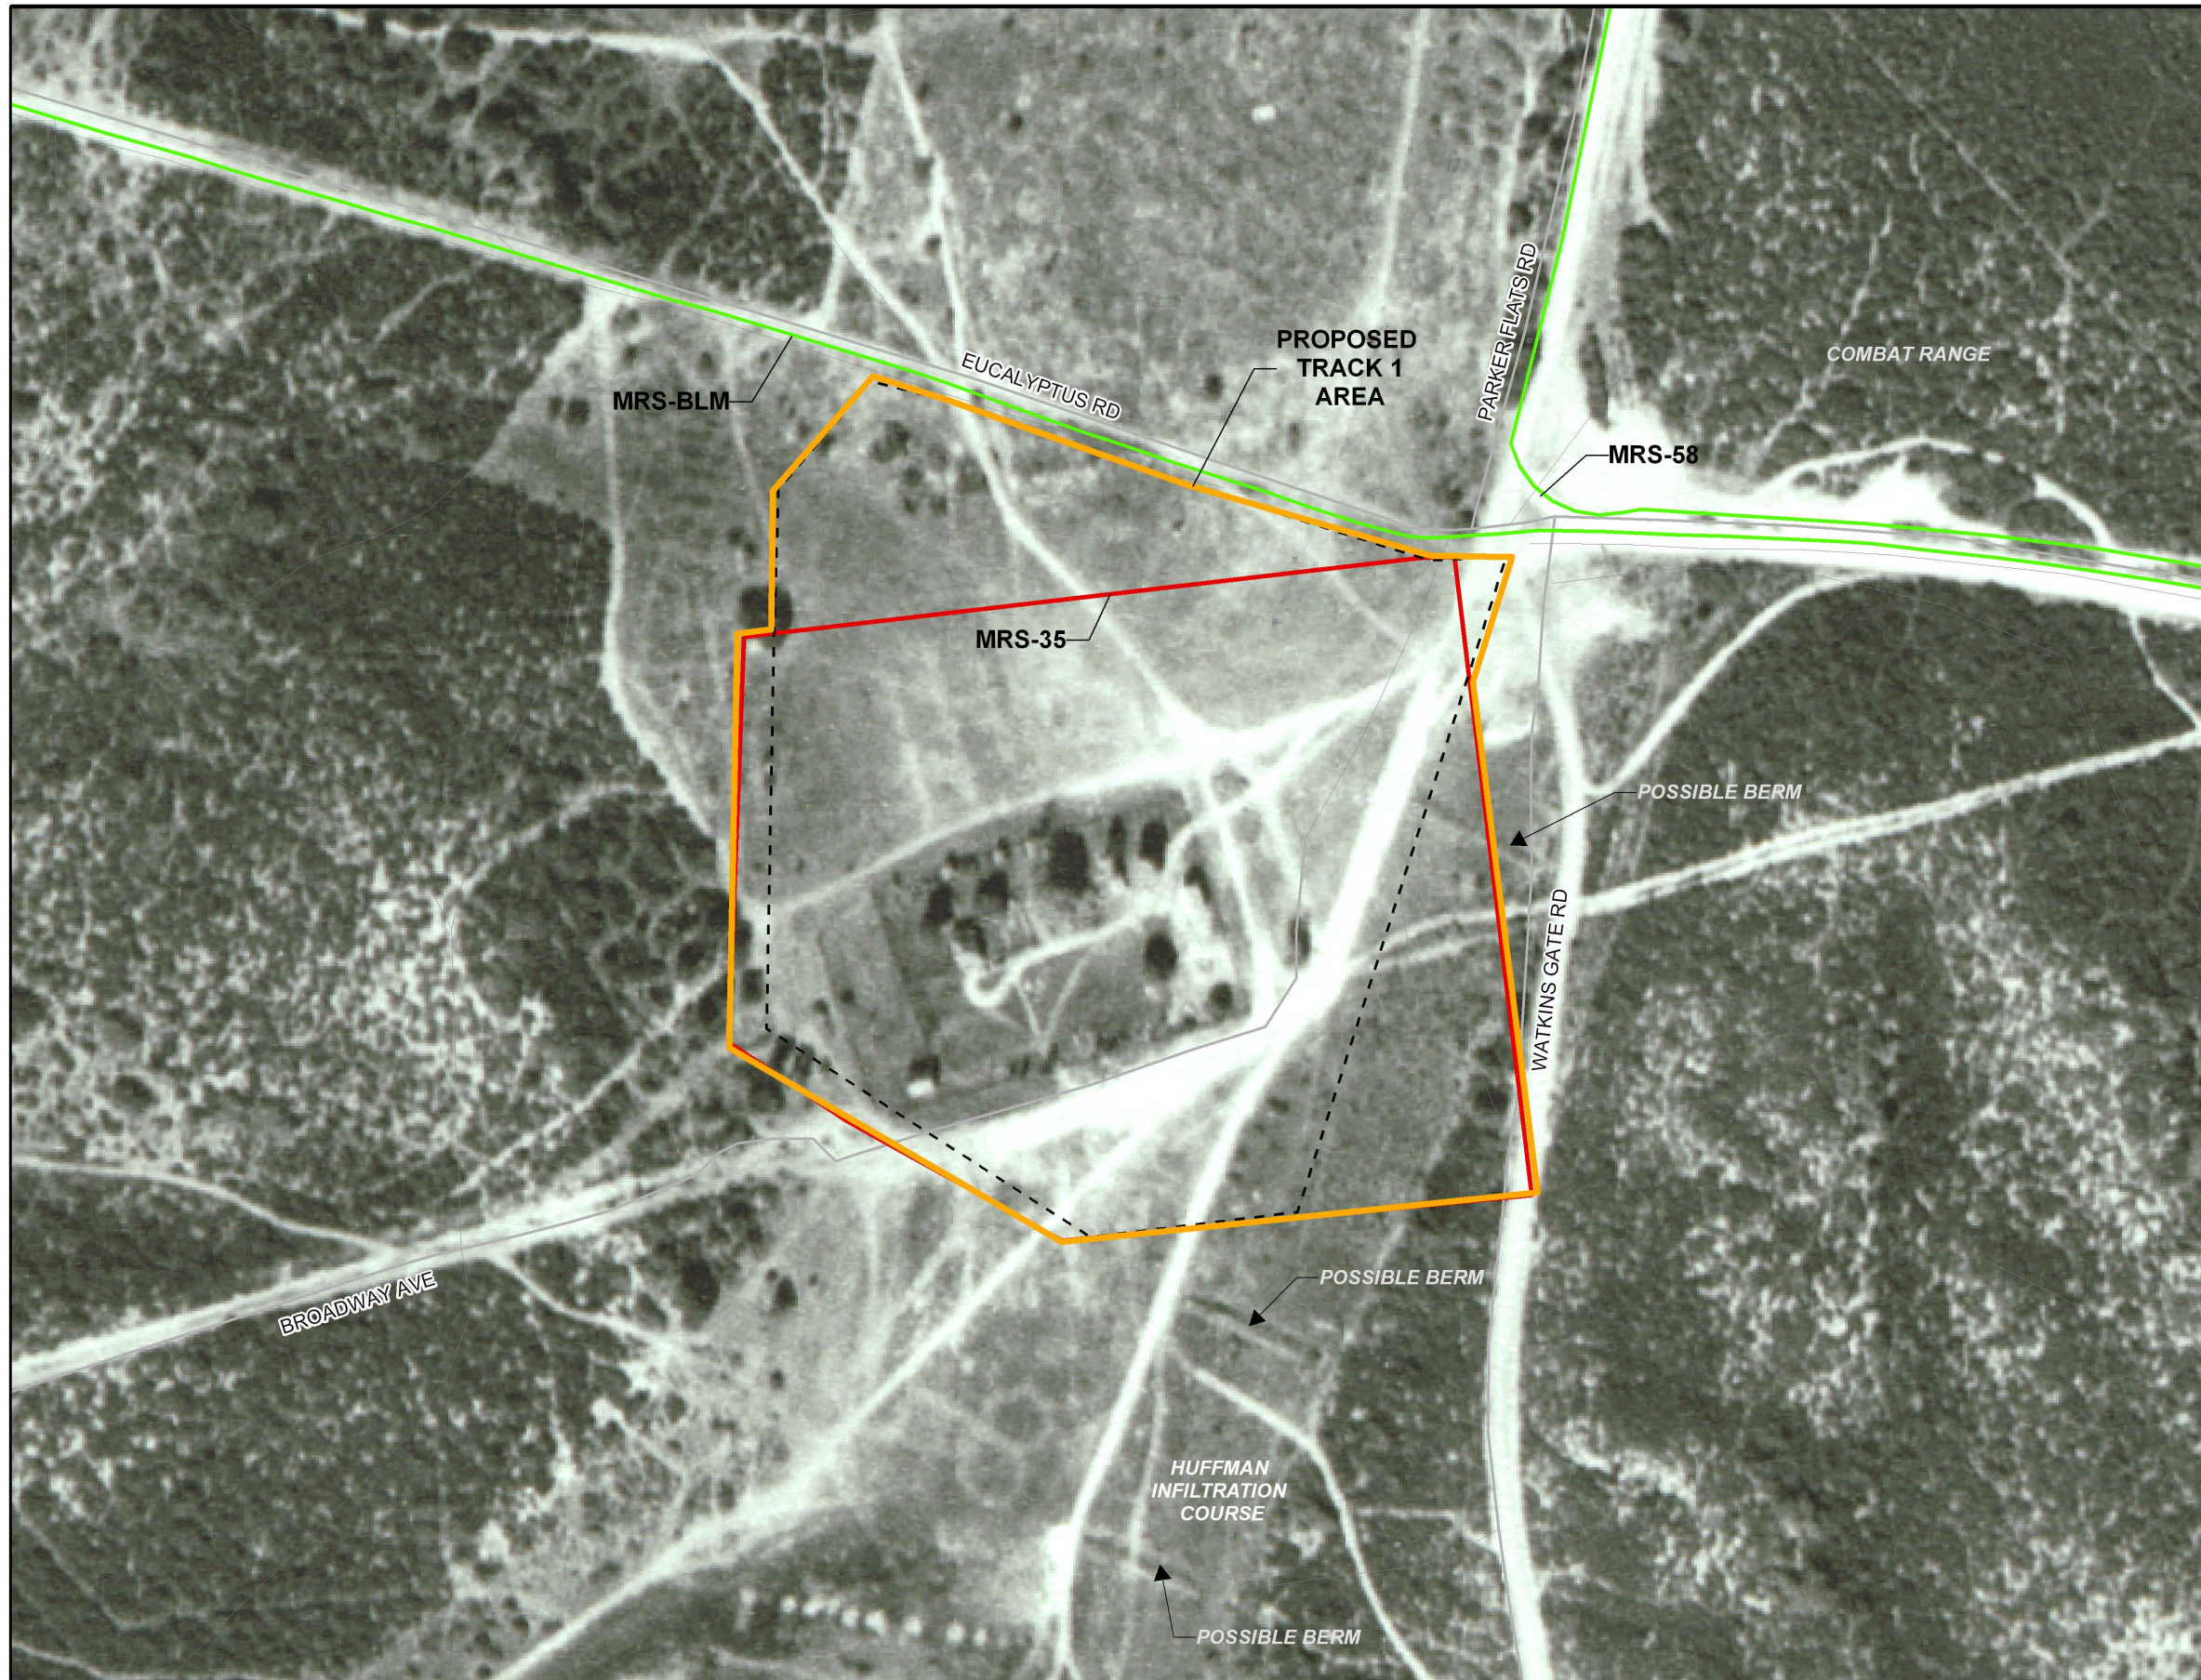
1941 Aerial Photograph and
Training Facilities, Circa 1945

Review of 1940s documentation and aerial photographs indicates the site was developed as a camp with buildings and fences in the same general location as at present (Plate 2-2). An infiltration course and target range were located south of the site. More specific information is provided below.

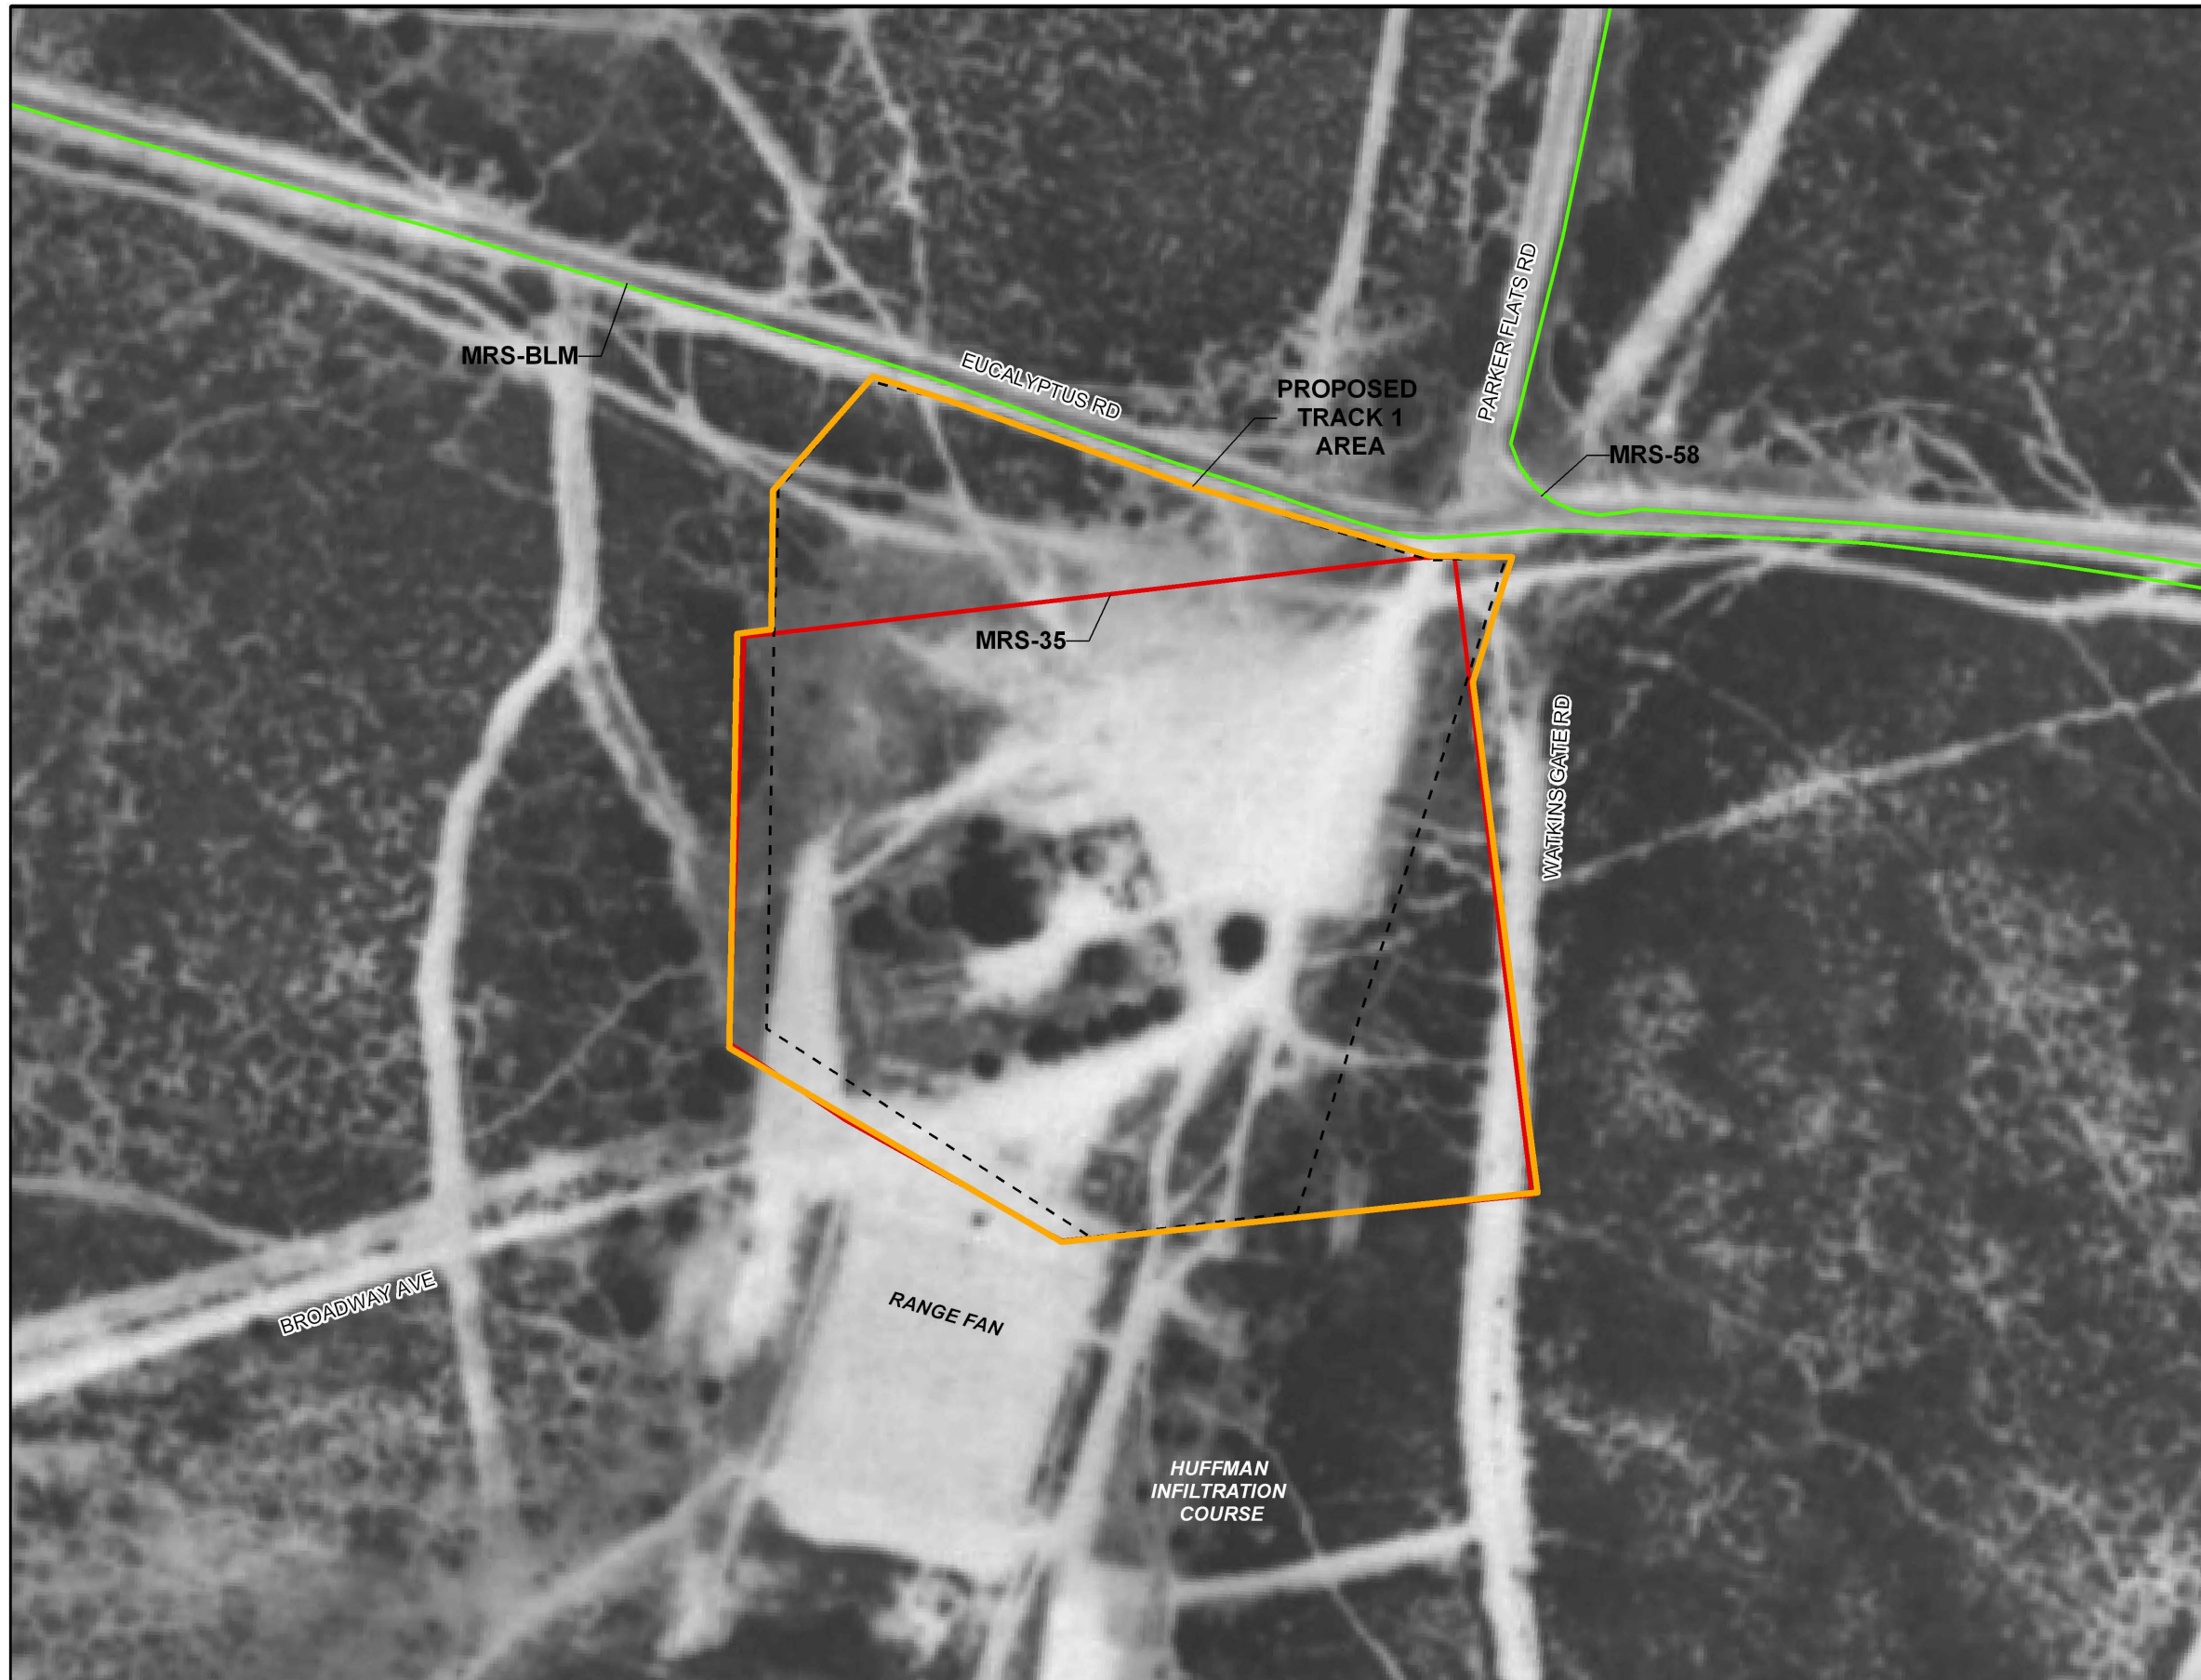
1955 Aerial Photograph and
Training Facilities, Circa 1957

Historical maps from “After 1953” and 1956 (*Army, After 1953, 1956a, and 1956b*) show the area south of Eucalyptus Road (location of MRS-35) as the Camp Huffman Ranger Station. The “After 1953 Map” shows Grant Training area west of the site and the 1956 Maps show a “106 RR” training area to the west. South of the site are an infiltration course and a rocket launcher range showing firing from east to west. Maps from 1957 and 1958 (*Army, 1957 and 1958*) show Mortar Range #3 (60mm) to the west, with firing from north to south. In these facility maps, the infiltration course and rocket launcher range are shown as located south of the site.

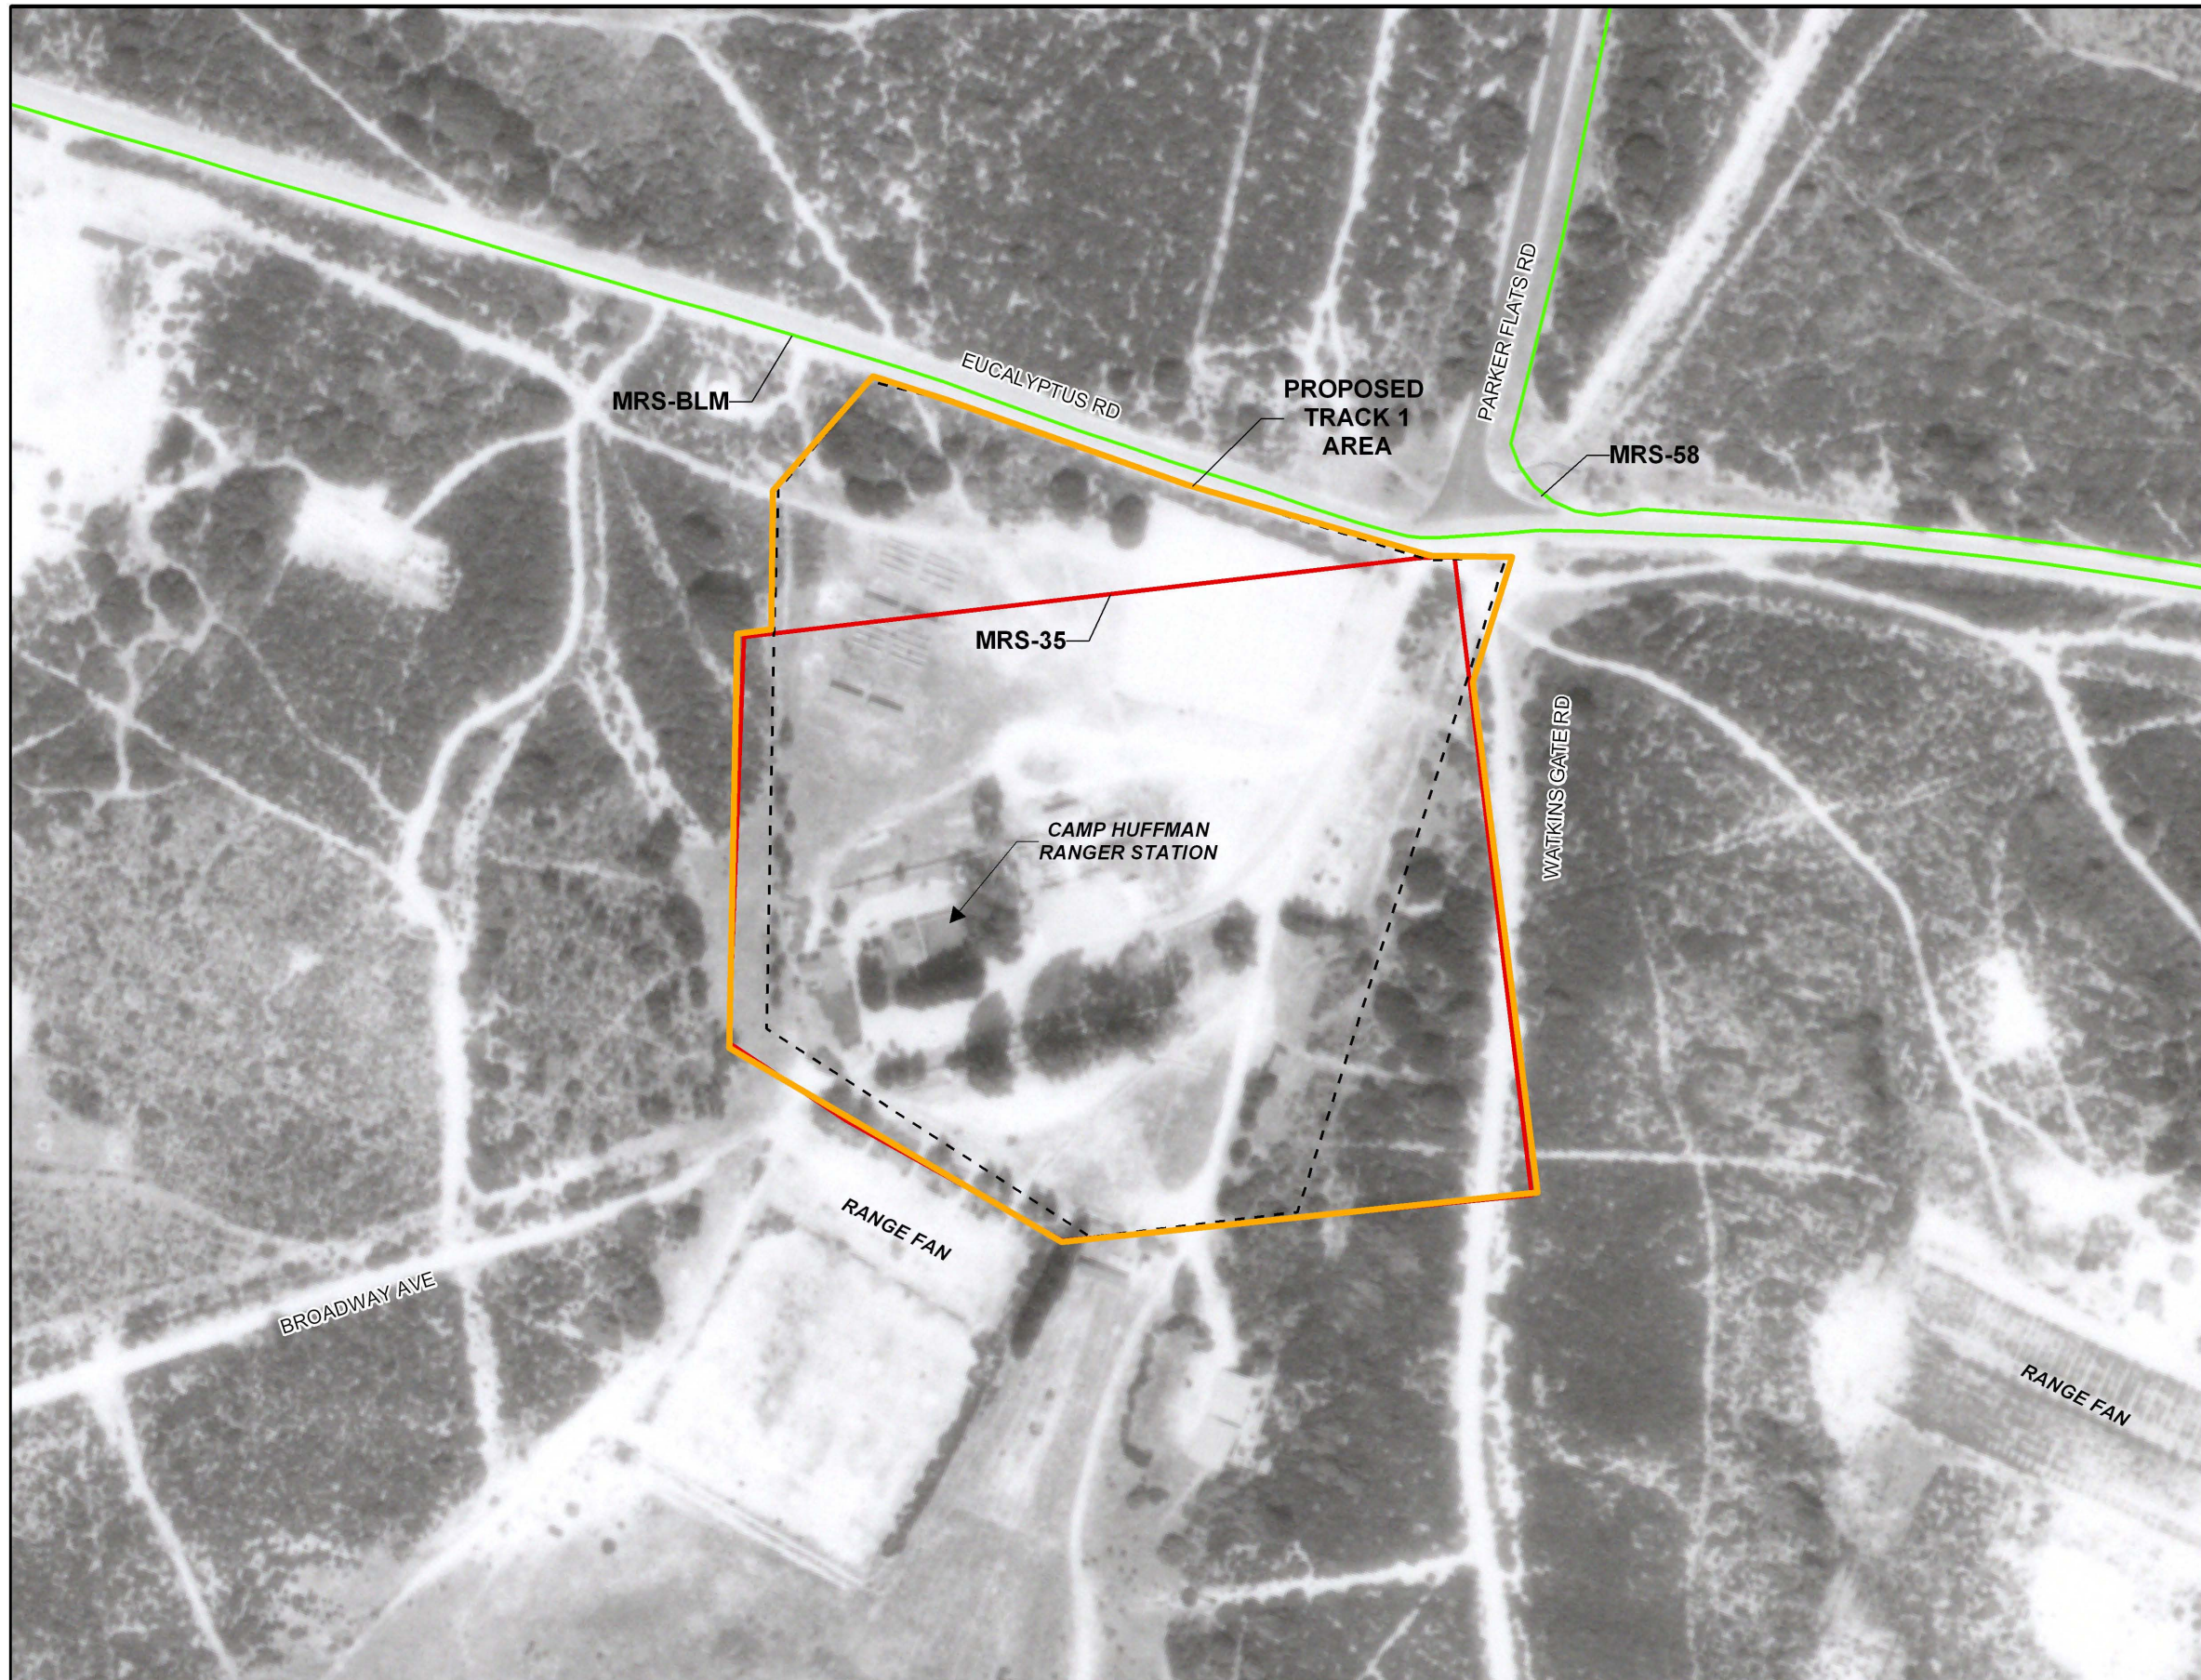
1974 Aerial Photograph and
Training Facilities, Circa 1972

Review of 1970s era documentation including training maps, aerial photographs, and other Fort Ord maps indicates that the site was still identified as Camp Huffman and was designated as Range Headquarters (Plate 2-4). Training areas to the south were used as an infiltration course and Bench Rest Range and to the west for recoilless rifle training. The two columns of linear features are present in a 1974 aerial photograph, possibly a structural framework, or bleachers, but were not observed in a 1978 aerial photograph. There is no designation on Army maps indicating the location or purpose of this observed feature.

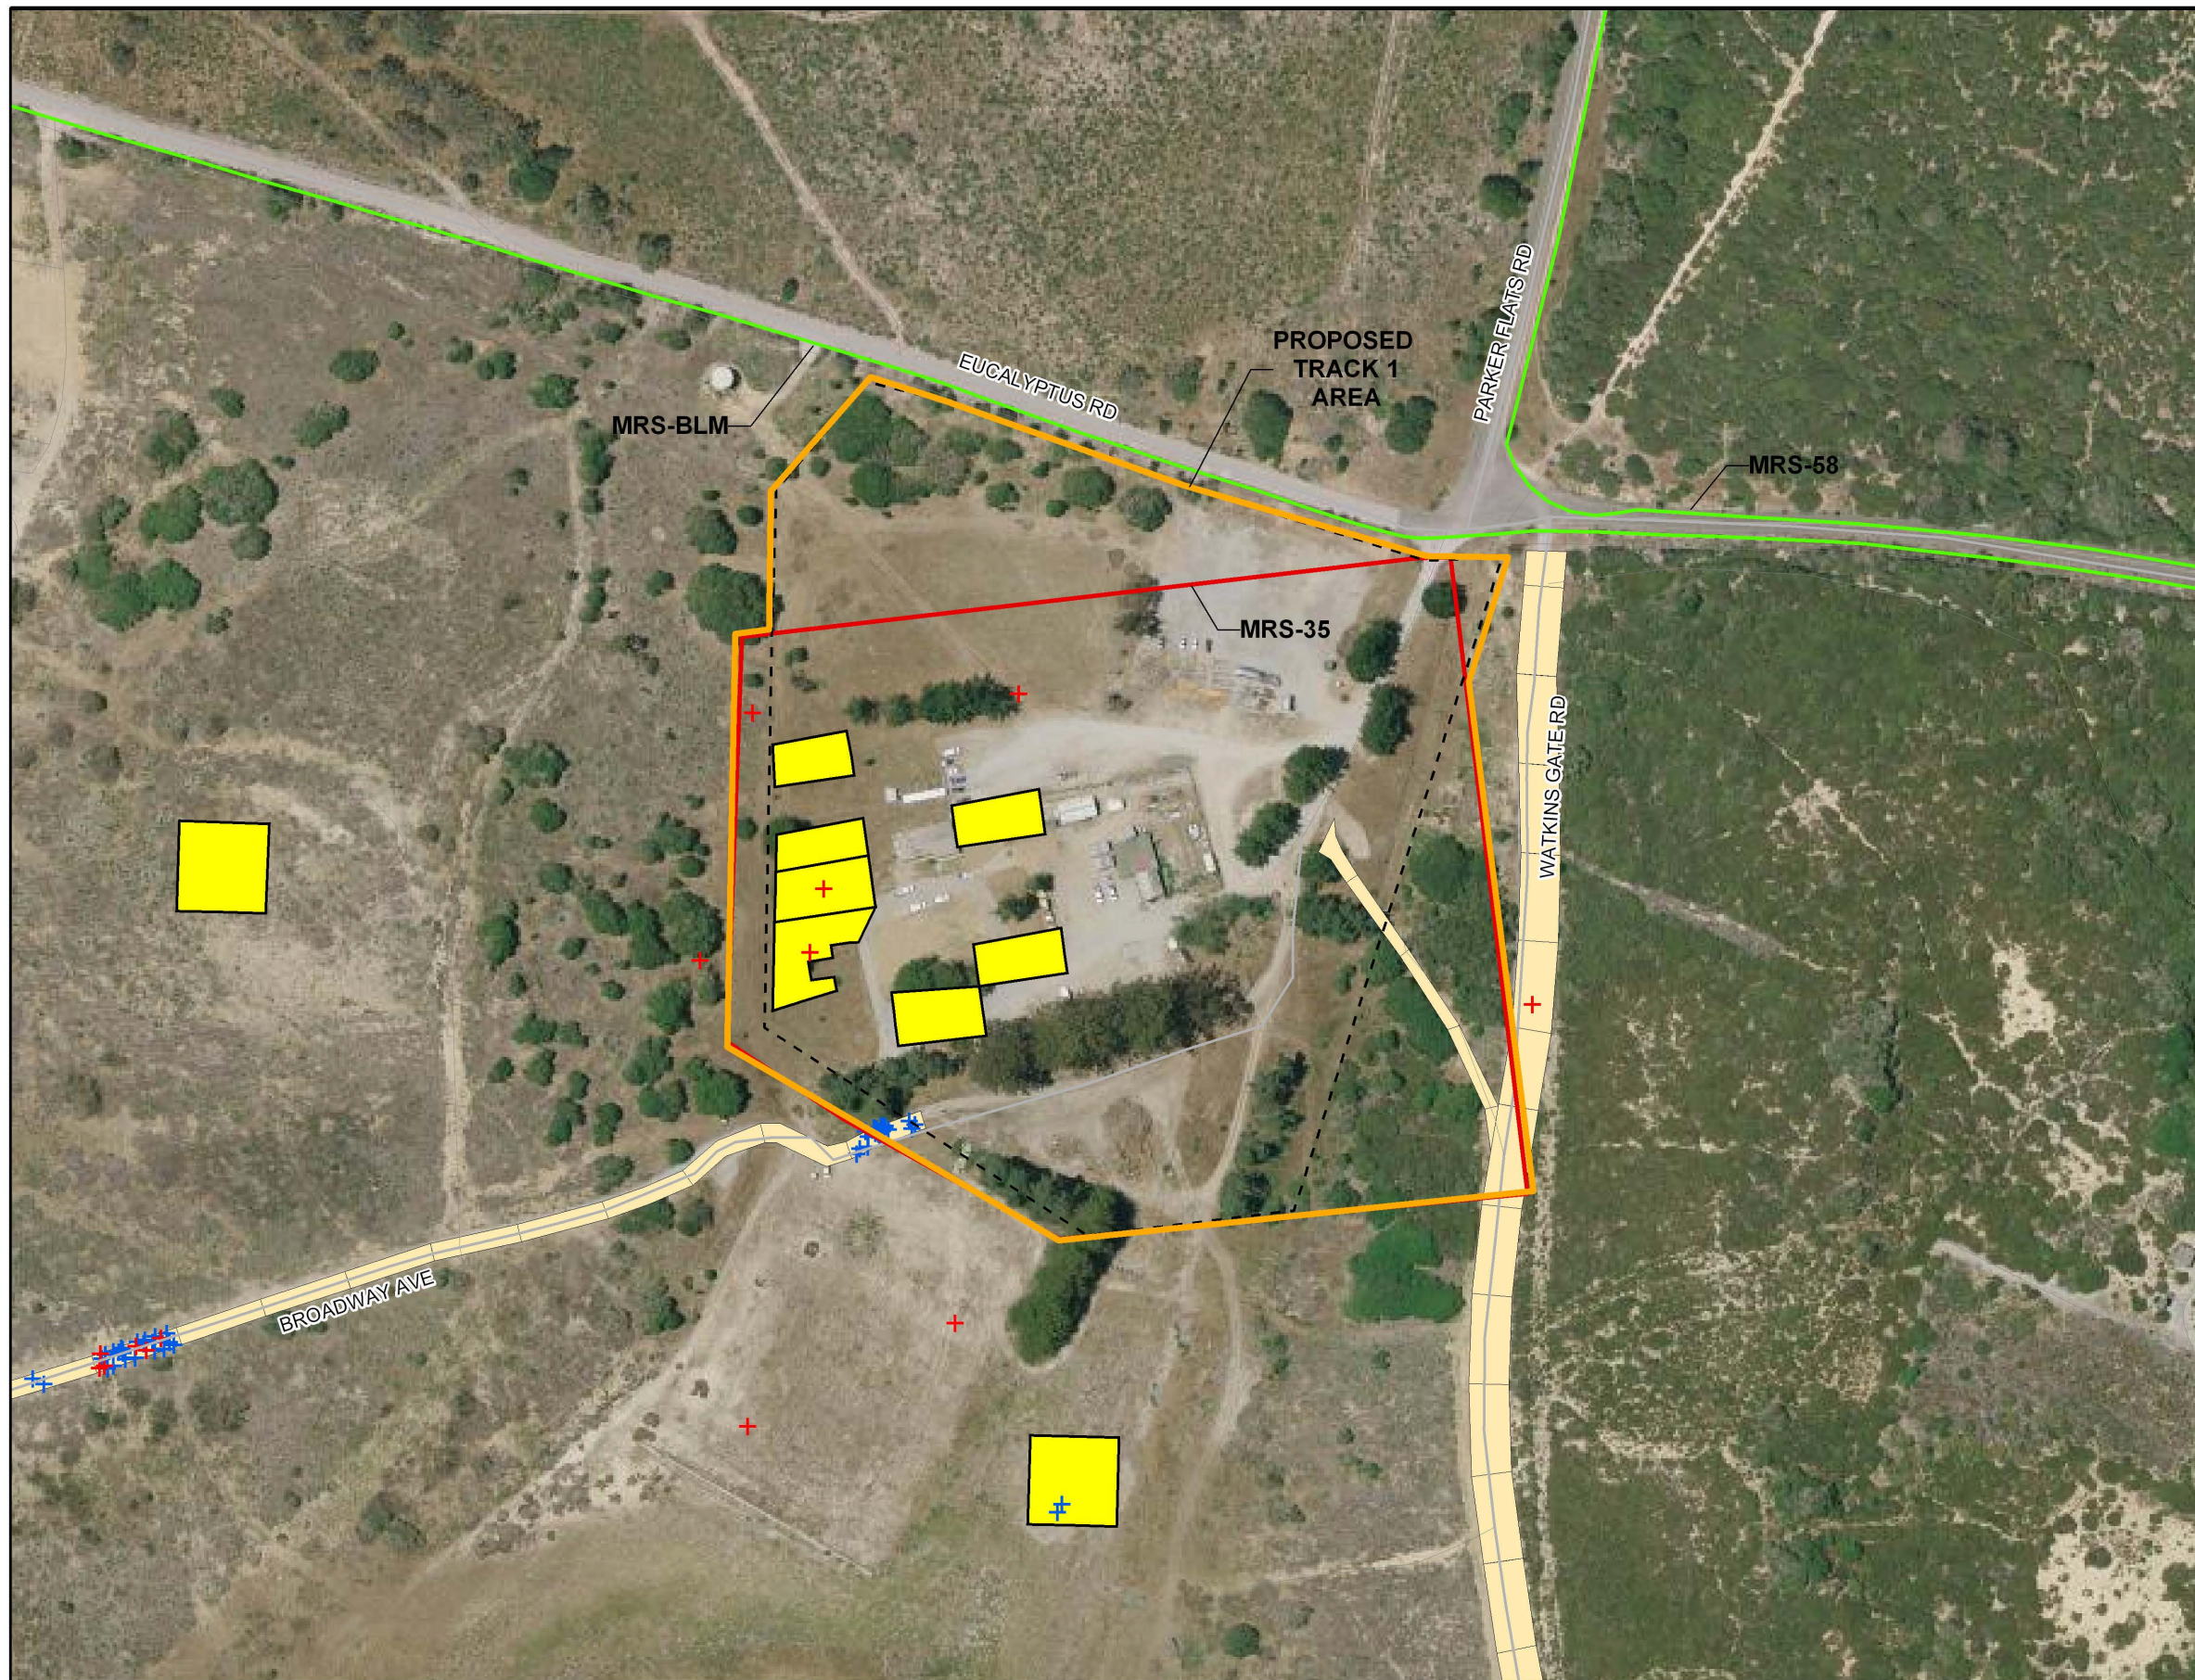
2009 Aerial Photograph,
MEC and MD Items, and
Sample Grids

Small arms cartridges, one expended 3.5 inch M29A2 practice rocket, one ground illumination signal, two grenade fuzes (one MEC and one MD) and 17 practice hand grenades (one MEC and 16 MD), and one smoke grenade (MEC) were found in the western and southwestern portions of the site. Schonstedt tools are not capable of detecting brass small arms cartridges; therefore, it is likely that the cartridges were visually identified by field personnel.
