## Site 39 Inland Ranges Habitat Restoration Status Update

October 27, 2023

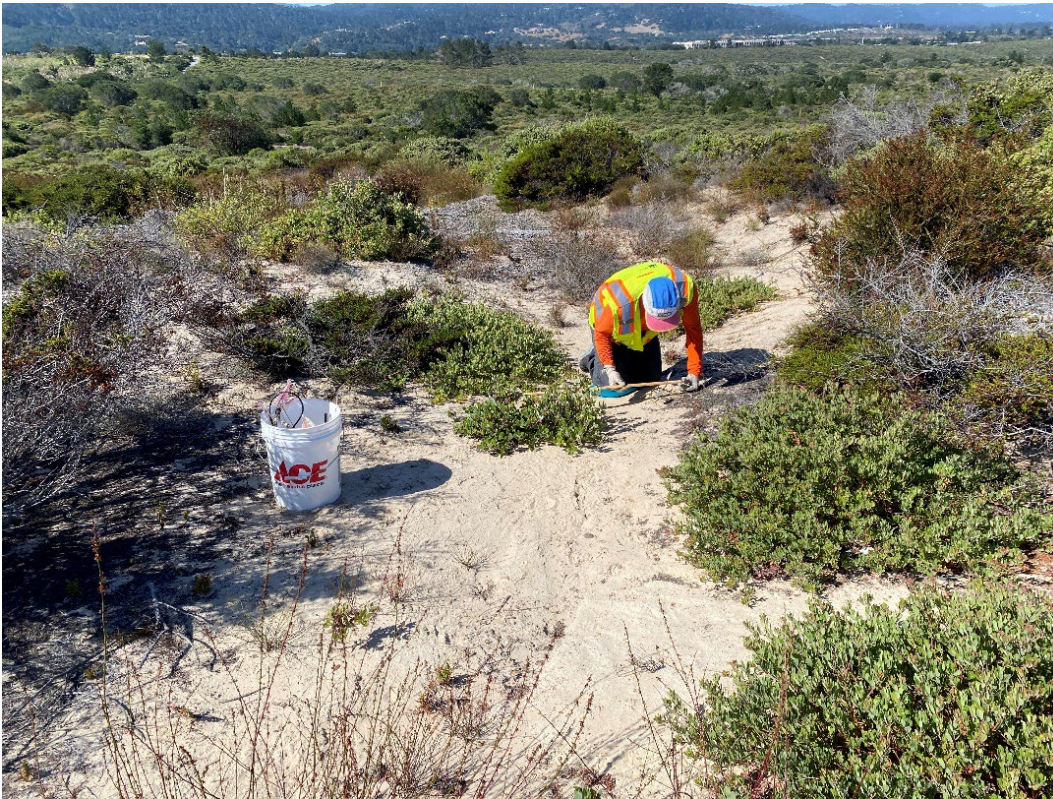
### Monitoring

- Plant survivorship monitoring was conducted at HAs 26, 34, and 37 in September 2023
  - Restoration plants are monitored for survivorship in years 1, 2, and 3 after planting occurs
- Fall Photo point monitoring was completed on October 10, 2023

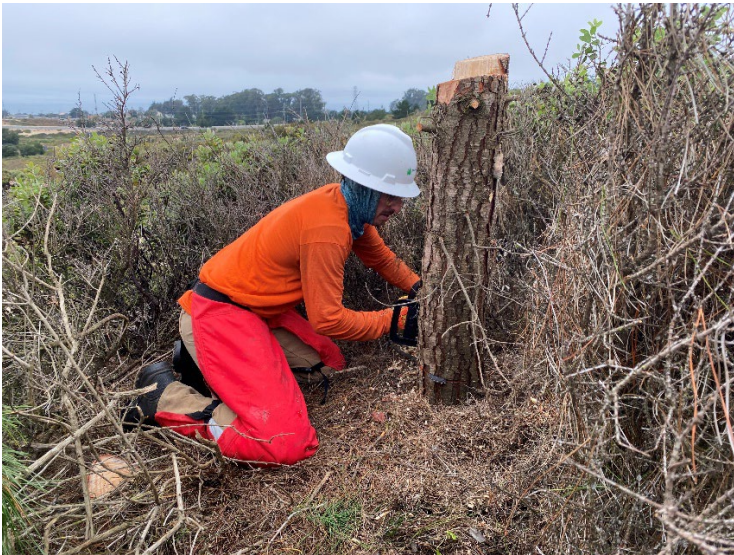
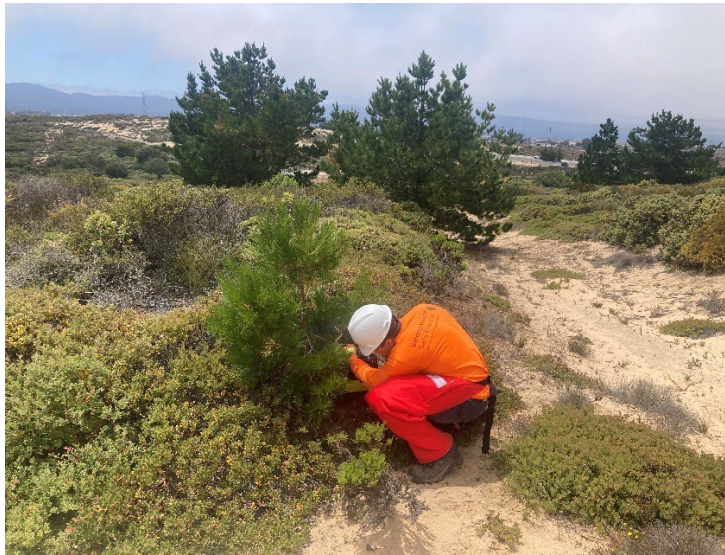
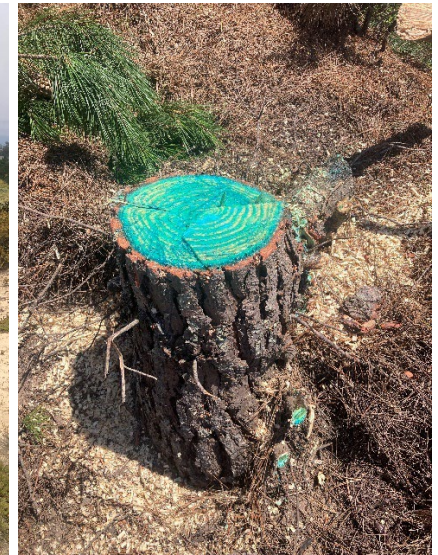
### Caretaker of Previous HA

- In July 2023, Burleson biologists removed 119 trees from HAs 19, 26, 27, 27A, and 34 with an electric chainsaw. Tree species removed include 116 Monterey pines (*Pinus radiata*) two Monterey cypresses (*Hesperocyparis macrocarpa*), and one golden wattle (*Acacia longifolia*).

- A small amount of glyphosate-based herbicide was applied to cut stumps, except when trees were small enough for hand removal of roots.
- All trees removed were encroaching on maritime chaparral habitat within or bordering open areas within the boundary of Site 39's HAs.

- Monterey pines shade out open sandy areas in maritime chaparral habitat where germination of rare annual plant species such as Sand Gilia (*Gilia tenuiflora ssp. arenaria*), Monterey spineflower (*Chorizanthe pungens var. pungens*), and Seaside bird's beak (*Cordylanthus rigidus ssp. littoralis*) are known to occur.

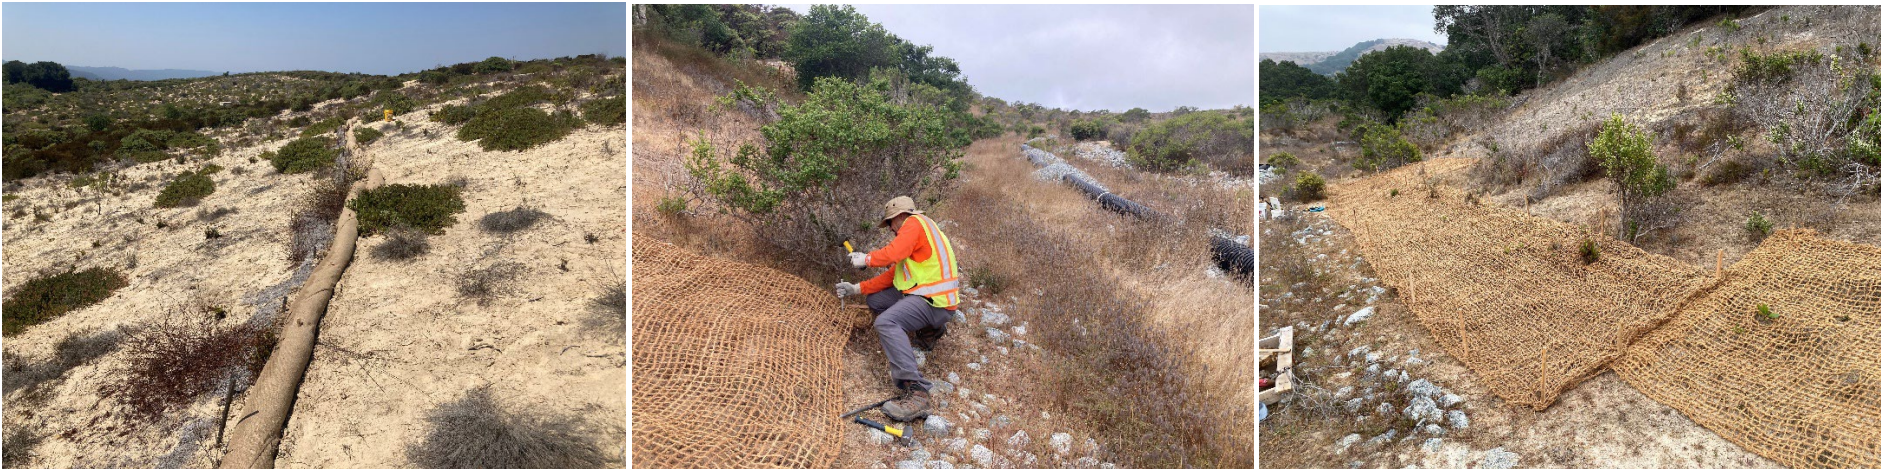
### **Erosion Control Repairs at HAs 26, 27A, 28, 34, and 37 (Sept-Oct 2023)**

- Installed 24 straw wattles (600 linear feet)
- Installed 1400 square feet of coir fabric
- Completed 400 linear feet of rill repair
- Maintained 200 linear feet of water bars
